CORRELATION TESTS OF THE DITCHING

BEHAVIOR OF AN ARMY B-24D AIRPLANE

AND A  $\frac{1}{16}$ -SIZE MODEL

MR No. L6A03

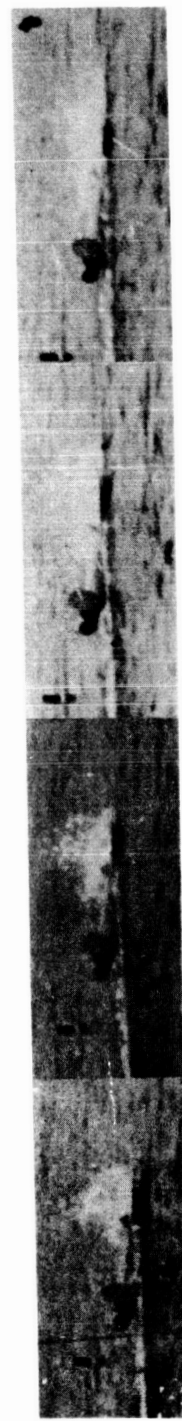
4.67 5.00  
Time, sec. (full scale)  
Model test (catapult)

Figure 4.- Continued.
